Modification Recommended Service Note

6655A DC power supply, 0-120 V, 0-4 A, 480 W. GPIB

The Problem – 6655A exhibited out of specification values for 61.0V to 61.6V at front panel read back readings.

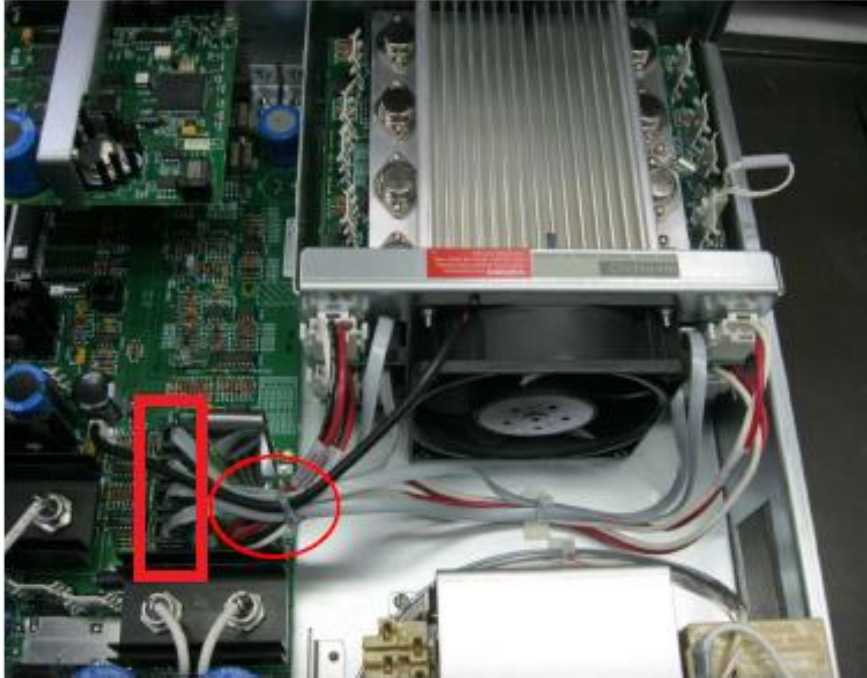
d. Disconnect 4 phone cables and cut the cable tie

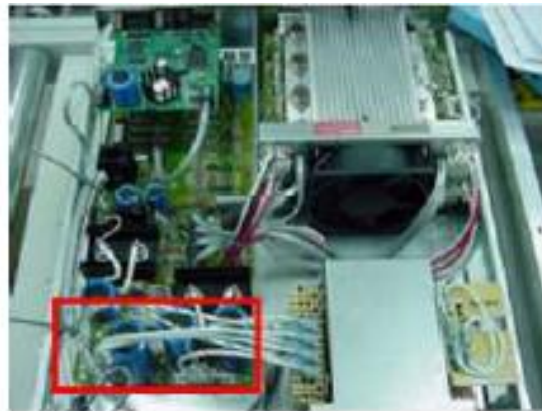
- e. Disconnect cables from transformer, the number of cables varies base on model 6x51A, 6x52A, 6x53A, 6x54A and 6x55A.

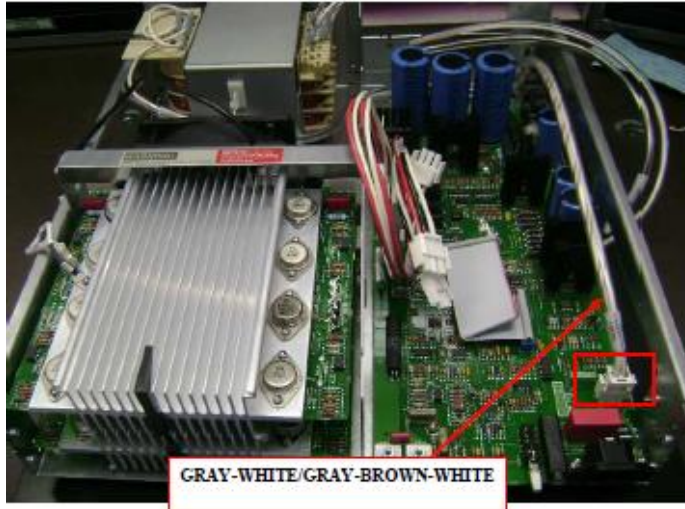
- f. Disconnect cable J450 on PCA.

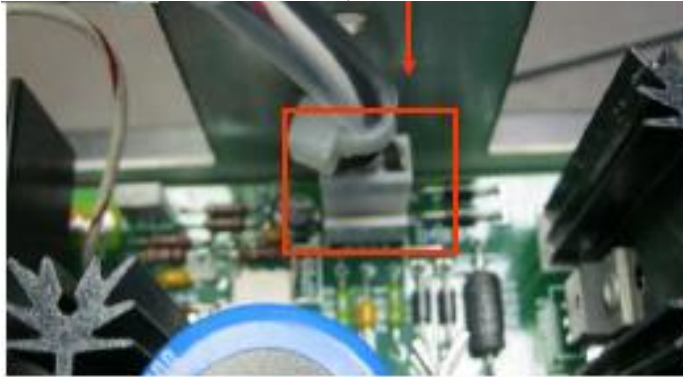
g. Disconnect J600 on PCA input as shown.

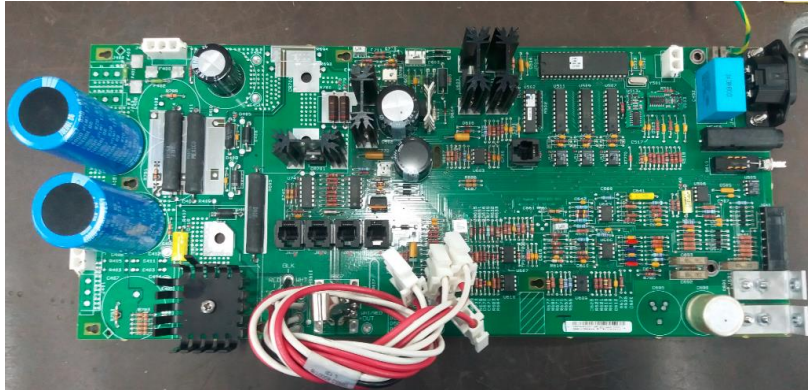
10. Replace with a new PCA board (06655-61020)

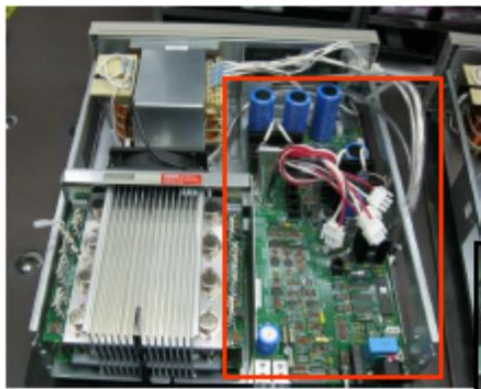
11. Lodge the PCA into the 6 key pin, then slide to lock it to the chassis.

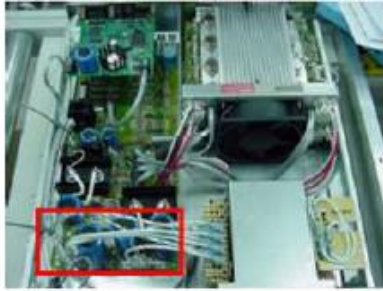
15. Connect cables from transformer, the number of cables varies base on model 6x51A, 6x52A, 6x53A, 6x54A and 6x55A.

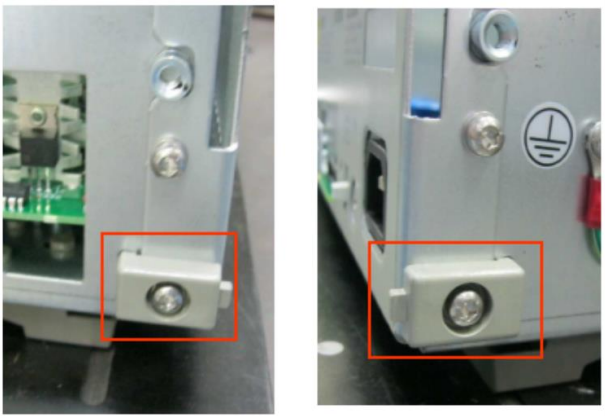
21. Attach cover block to the back cover and chassis by tighten the screw at each side.

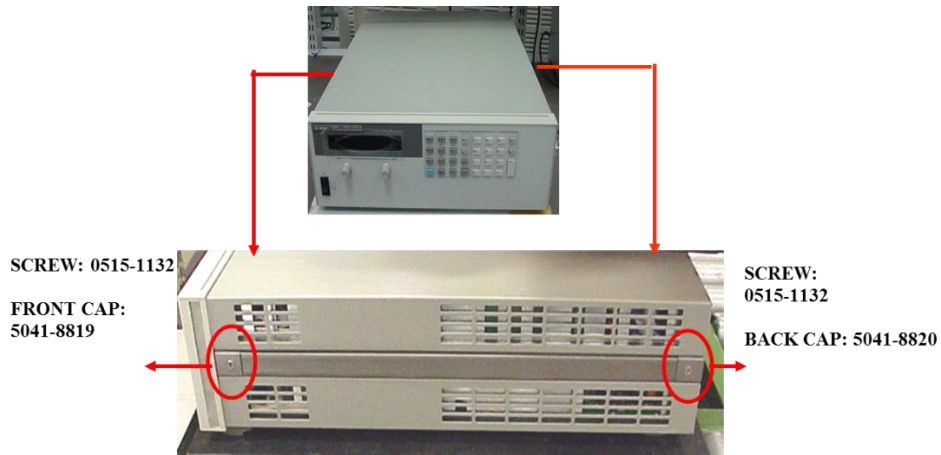
22. Mount the handle, front cap and back cap to both sides of cover with 2 screws as shown in the

following picture as below
