## S E R V I C E N O T E

**HP 70846A 3Gbit/s Error Detector Module****Serial Numbers:** 3017U00101 / 3206U00114**Module causing Mainframe/Display Shutdown****Situation:**

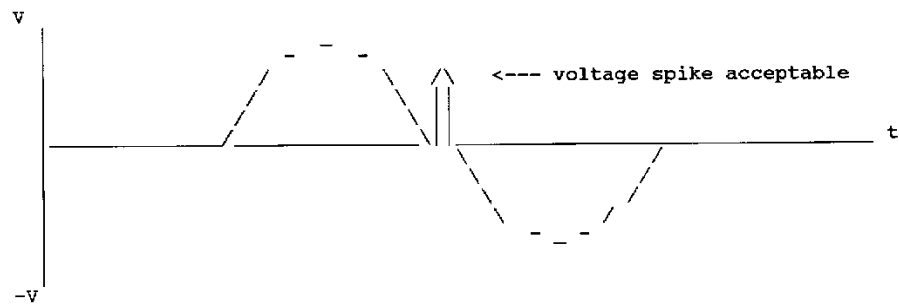
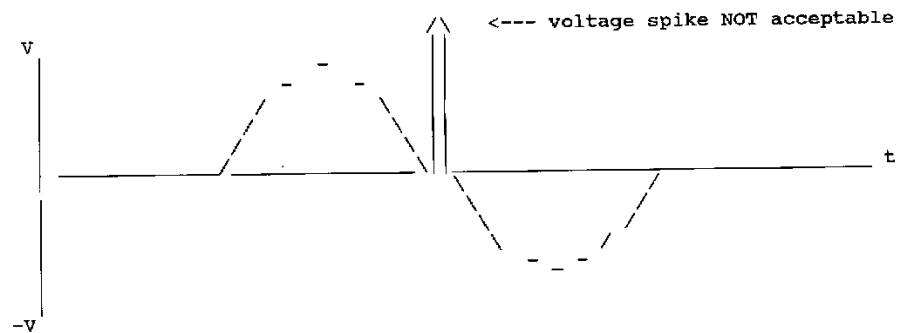
4. Fit the module extender assembly HP p/n 70001-60013 into the Mainframe (or Display) and attach the cable from this extender assembly to the socket on the rear panel of the HP 70846A module.
5. Connect an oscilloscope to TP 40kHz on the module power supply assembly HP p/n 70841-60002.
6. Switch on the Mainframe (or Display) and adjust the oscilloscope timebase and amplitude to display a single pulse across the screen. Some ringing on this pulse is acceptable, but if the voltage spike appears excessive the PSU should be changed for new assembly HP p/n 70841-60102.

7. With the new PSU assembly fitted, check the typical supply voltages are as shown here (test points exist for these).
