**81150A-06**

# S E R V I C E N O T E

## 81150A Pulse Function Arbitrary Noise Generator

**The instrument starts to boot but eventually the front panel display will stay dark.**

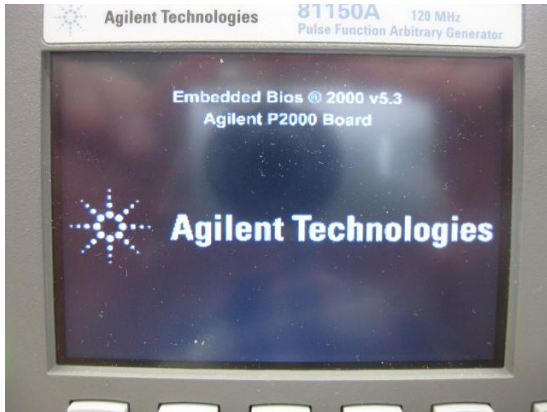
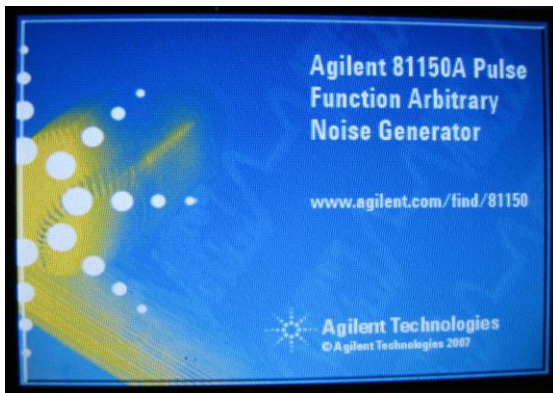
You will see the following progress on the display:

However, after sequence above the front panel display stay dark.

The communication between the processor board and the main board is not working correctly or is broken completely.

Try to reboot the instrument at least 2 times. Disconnect the power cord and wait for at least 30 seconds before re-connecting and restarting again.

1. Try to reboot the instrument at least 2 times. Disconnect the power cord and wait for at least 30 seconds before re-connecting and restarting again.
2. Take the Service Guide of the 81150A and open chapter "How to Remove and Replace the 81150A Main Board".
3. Replace the main board assembly. Do not separate processor board and main board.
