E3610A-06E-S

S E R V I C E N O T E

E3610A - Manual DC Power Supply

POSSIBLE SHOCK HAZARD

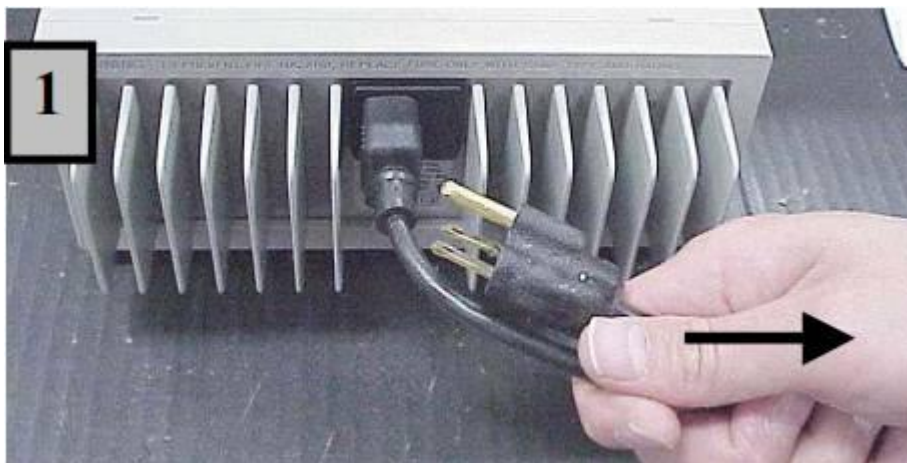
**CAUTION: TEST FOR LOOSE AC MODULE**

1. Make sure line cord is removed from outlet.
2. With line cord securely inserted in AC module as shown, pull forcibly (2 times) in direction of arrow.

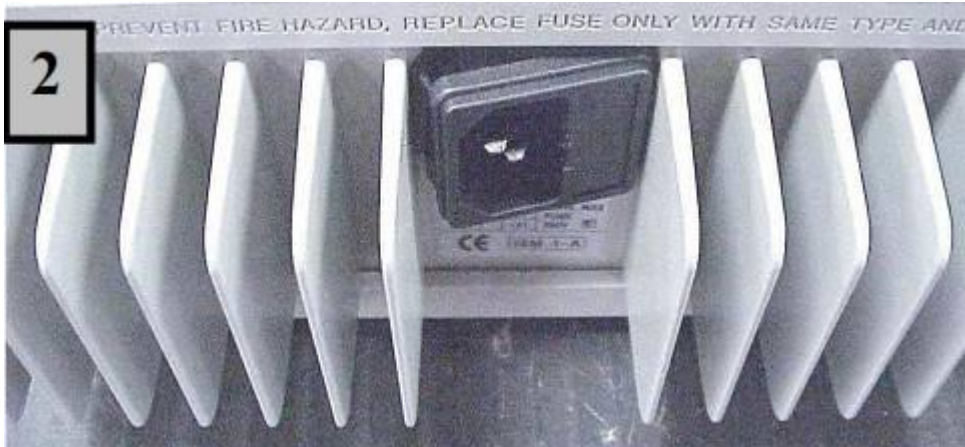
LOOSE AC MODULE

1. If the AC module pulls out from unit as shown it will need to be replaced.
2. If the AC module remains in place it does not need to be changed. Put a mark on the AC input label in the lower left hand corner with indelible ink to indicate that AC module has been checked. This label can be found below the AC module.

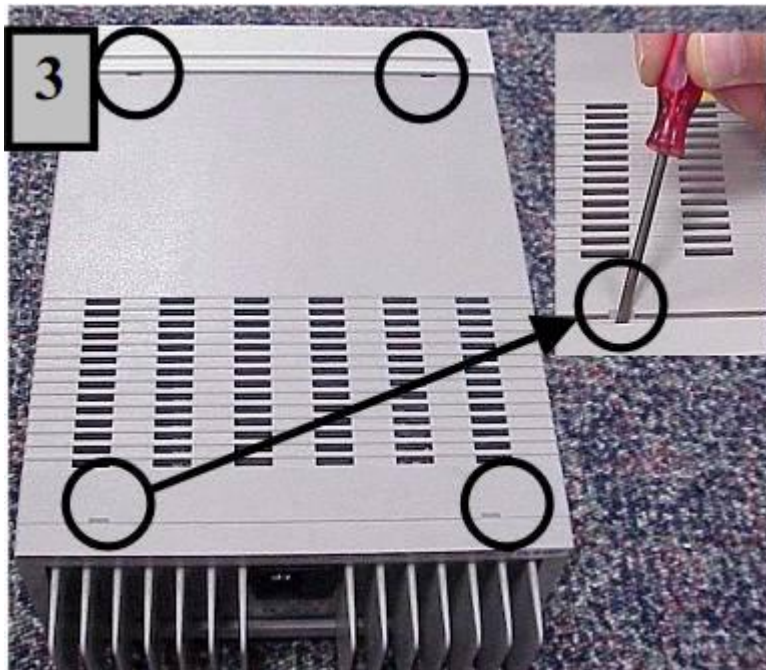
REMOVE COVER by prying rear bezel and front panel away from cover in four places as shown. Then lift cover off unit.

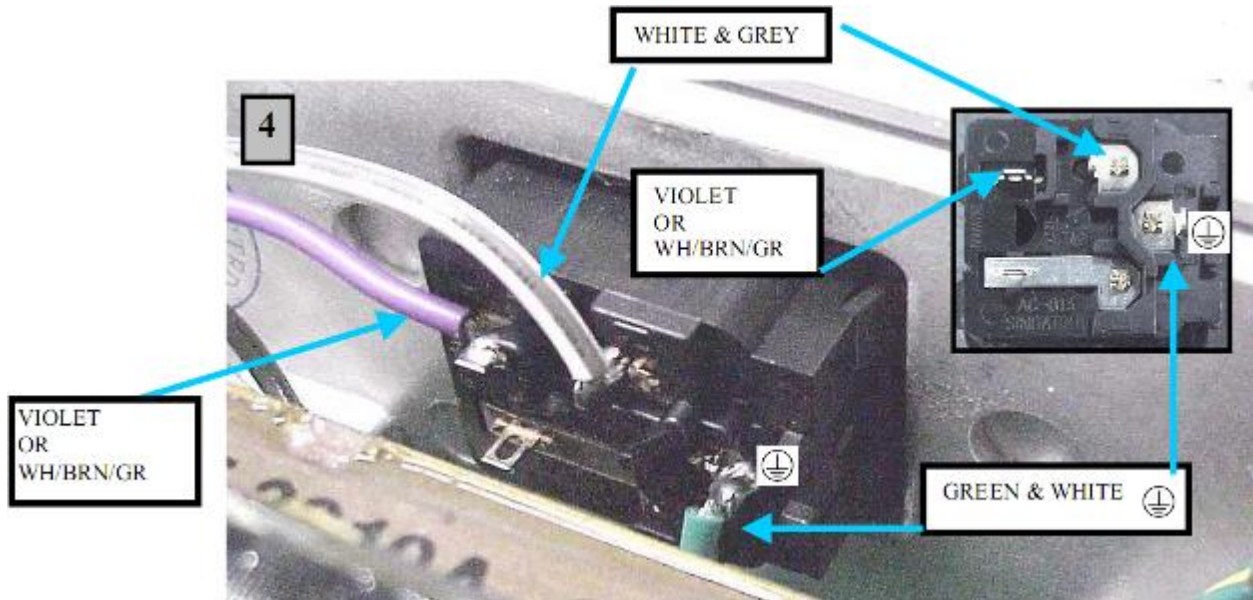
REPLACE MODULE with P/N 5065-6978. Before soldering perform “TEST FOR LOOSE AC MODULE” as shown in the picture above. This will confirm that the new module is secure. Solder wires and **REPLACE FUSE**.

110/120 VAC input use fuse P/N 2110-0702 (2 amp, 250 volt)

230 VAC input use fuse P/N 2110-0599 (1 amp, 250 volt)

CAUTION: WIRING MUST BE CORRECT OR HEAT SINK COULD BE AT LINE POTENTIAL.

CAUTION: MAKE SURE SAFETY GROUND

IS ATTACHED TO HEAT SINK.

After AC module is soldered, replace cover and turn it on. No calibration or specification verification is required.

Put a mark on the AC input label in the lower left hand corner with indelible ink to indicate that the AC module has been replaced. This label can be found below the AC module.
