E4416A-08

S E R V I C E N O T E

Agilent E4416A EPM-P Peak & Average Power Meter

Front Panel Repair Procedure

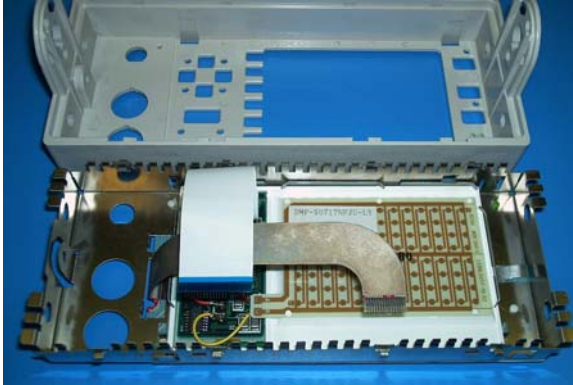
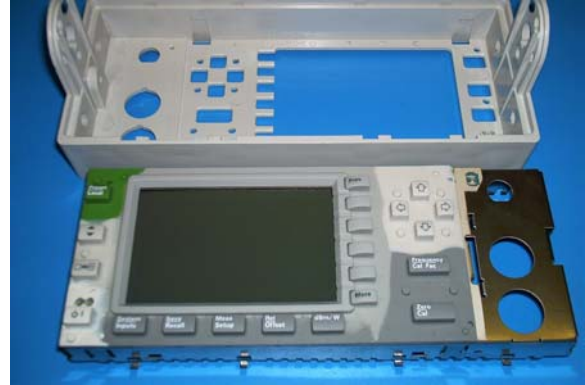
Figure 2

- Carefully lift the EMI Screen out of the Plastic Front Bezel. Figures 2 and 3 show different views of the removed assembly.

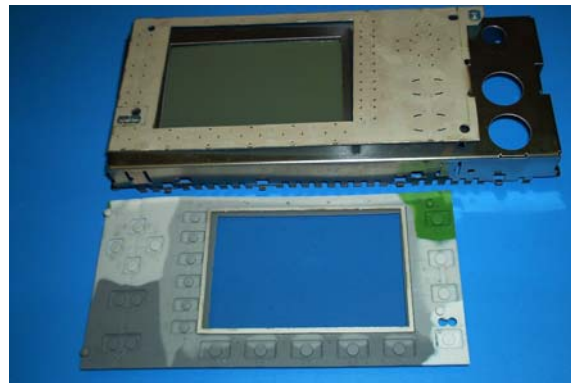
- Carefully remove the Rubber Keypad, taking care not to damage the EMI Shielded Window that is positioned between it and the EMI Screen. Take note that the edges on one side of the EMI Shielded Window are coated with a special paint – when refitting this part, the painted edges must face towards the EMI Screen. Figure 5 shows a picture of the EMI Screen with the Rubber Keypad and EMI Shielded Window removed.

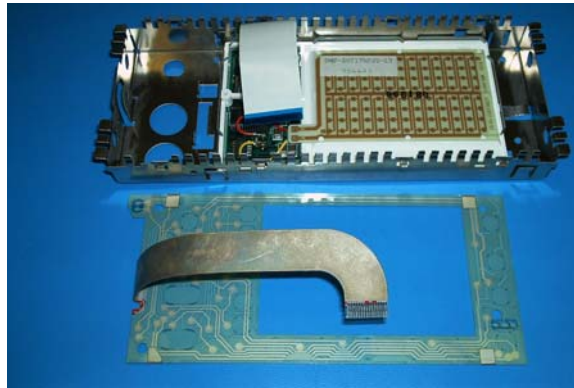
6. Carefully remove the Keypad Flex Circuit from the EMI Screen. Note that this part is not secured to the EMI Screen, and can be easily removed by pulling the flex tail through the slot in the metal. Figure 6 shows a picture of the EMI Screen with the Keypad Flex Circuit removed.
