E4416A-15A

<u>SERVICE NOTE</u>

E4416A - EPM-P Power Meter

Power Meter Display Shrink

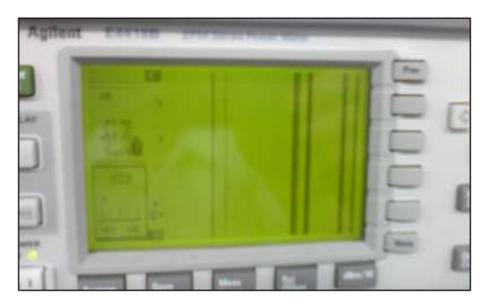
Due to some issues with the implementation of new LCD display controller in the power meter's display, intermittent display shrink is observed when operating the power meter. This however doesn't impact all the units. The display shrink scenario may look like something shown below:

To resolve this problem, replace the front panel assembly with a good one. A good front panel has additional Transient Voltage Suppress (TVS) diode soldered on its PCA **OR** additional ribbon cable with Damping Resistors attached to it. The photos for good front panel assembly are shown below. Additional of TVS diode **OR** Damping Resistors will prevent the display shrink from happening.
