E4417A-05

S E R V I C E N O T E

Agilent E4417A EPM-P Peak & Average Power Meter

Replacing A Defective Rivet-Fit Line Module

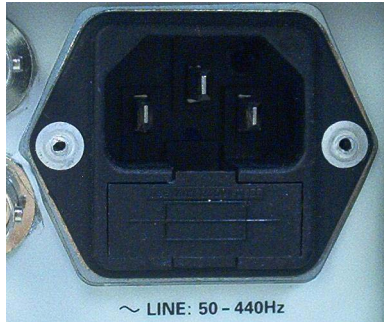
Figure 1 shows the rear panel view of a rivet-fit line module, whilst Figure 2 shows the rear panel view of a push-fit line module.

Agilent does not recommend direct replacement of the rivet-fit line module in the power meter. This is for the following two safety related reasons:

- Metal fragments from the old rivets might not be completely removed.
- Electrical earthing might be compromised if the new rivets are not fitted correctly.

For these reasons, Agilent recommends that, in the event of line module failure, the chassis assembly be replaced. The chassis assembly comes with a push-fit line module, such that the repair method for any future line module issues becomes much simpler.
