E4419B-13

S E R V I C E N O T E

Agilent E4419B EPM Average Power Meter

Replacing A Defective Rivet-Fit Line Module

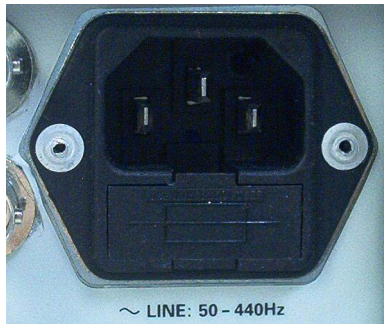
Figure 1 shows the rear panel view of a rivet-fit line module, whilst Figure 2 shows the rear panel view of a push-fit line module.

For these reasons, Agilent recommends that, in the event of line module failure, the chassis assembly be replaced. The chassis assembly comes with a push-fit line module, such that the repair method for any future line module issues becomes much simpler.

This Service Note only applies to power meters that use rivet-fit line modules. If any of the units listed in the above serial number ranges are received at the service center, and are exhibiting a fault with the rivet-fit module, then perform the following procedure:
