E4980AL-13

# Modification Recommended Service Note

## E4980AL Precision LCR Meter, 20Hz to 300kHz/ 500kHz/ 1MHz

E4980A/AL Keypad Stuck While Using Instrument

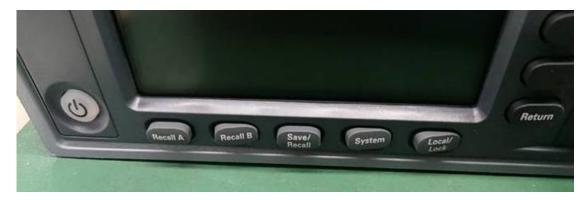
User may find that the instrument's keypad stuck as the picture below while using the instrument. If user reported to have the keypad stuck issue with instrument serial number listed, refer to solution.

The reason behind is that there is issue in supplier's molding causing the front panel to have burr that leads to keypad stuck.

Send your instrument to the nearest service center. The service center with repair capability will then perform the following:

- 1. Replace front panel E4980-40051.
  Refer to Front Panel Assembly Removal in E4980A/E4980AL Precision LCR Meter Service Guide for the procedure to remove and replace the front panel.
- 2. Power-on the instrument after replacement. Check for any error message or any display failure. Refer to Power On Sequence Troubleshooting in E4980A/E4980AL Precision LCR Meter Service Guide for troubleshooting details.
