# E5052B-04A

## S E R V I C E N O T E

### E5052B Signal Source Analyzer

**Automatically shut down after a few seconds beeping occurs when user turns on the instrument**

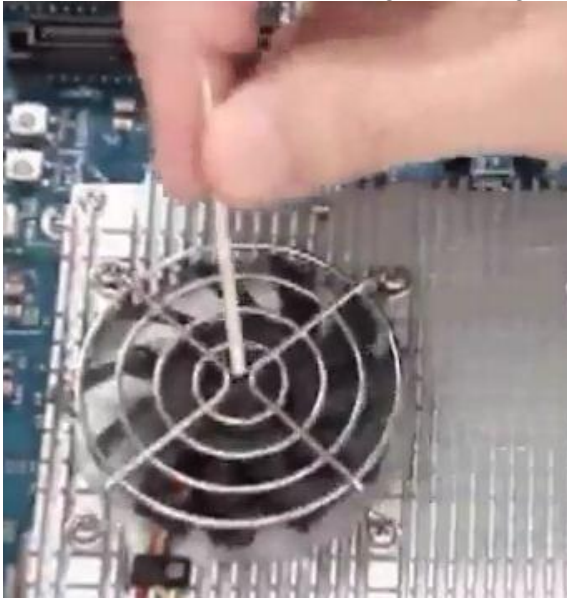
1. Push down CPU fan's rotor using something like tooth pick just after turning on power switch.

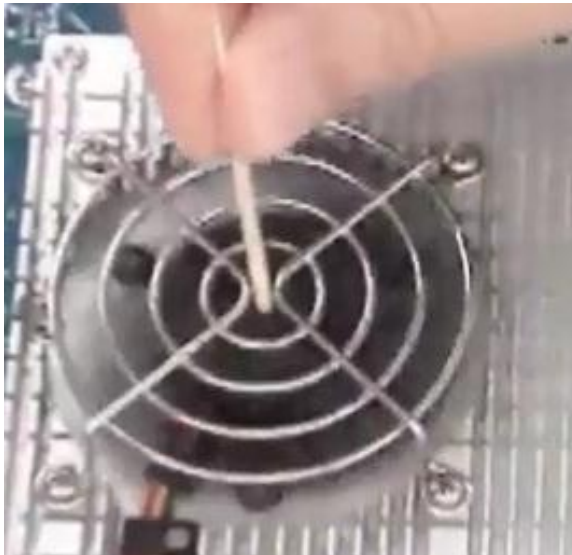
2. If CPU fan rotates, then the cause of the trouble is [dropped off rotor]

2-2-1. If CPU fan is COFAN, replace CPU fan with 3160-4452 for repair.

2-2-2. If CPU fan is COOLER MASTER, replace the whole CPU assembly with E5071-62060.
