N5183A-11A

# Information Only Service Note

## N5183A MXG Analog Signal Generator

**The Problem** – The N5180-60024 LCD Assembly is No Longer Available

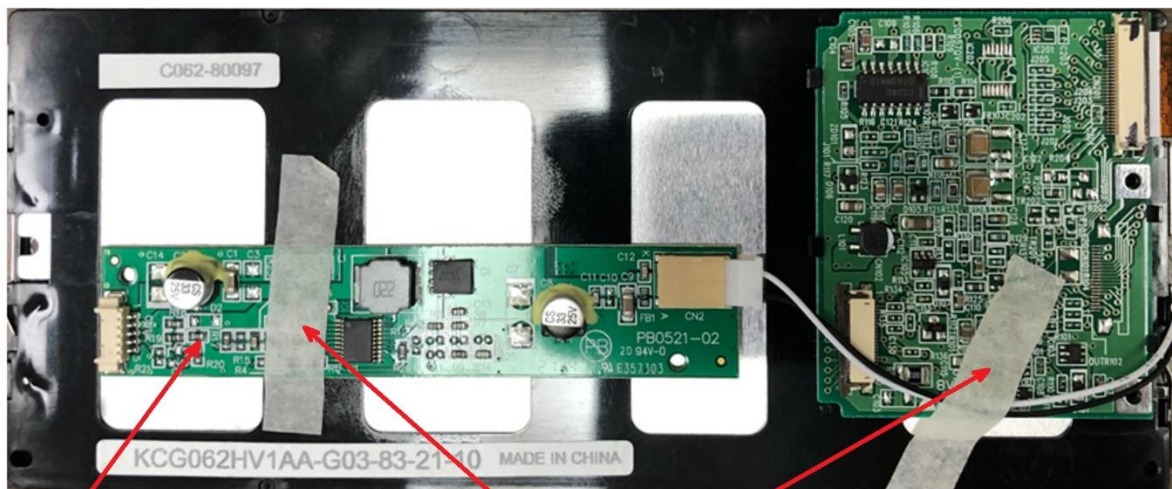
Figure 1 - Replacement LCD and Backlight Driver Board

Replacement LED  
Backlight Driver Board

Remove tape securing LED backlight driver  
board and wire harness  
before installation

1. Remove the tape securing the new backlight driver board and wire harness to the LCD assembly, as seen in Figure 1.
